Your Origin & Cause Solution

Fire Research & Technology, LLC

FRT 20-047

Prepared for: Estate of Charles Hollowell

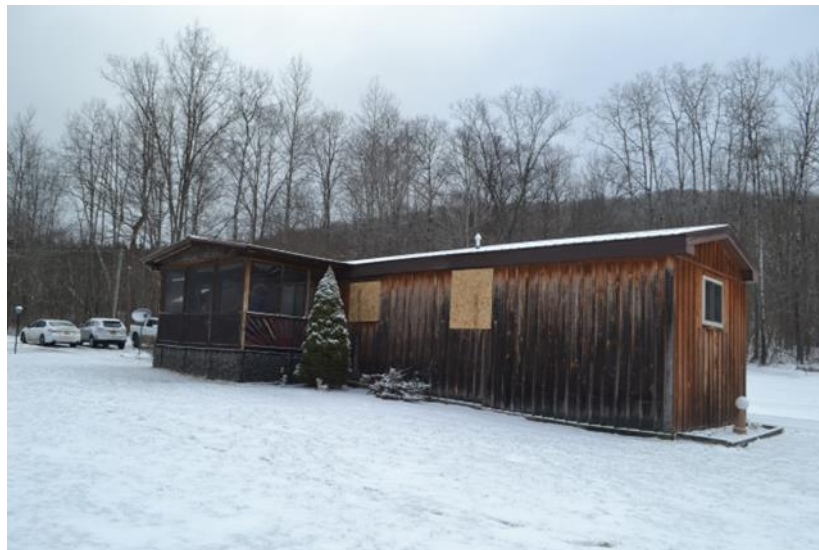
The exterior of the house was relatively unaffected by fire. Ventilation patterns were not observed on the exterior of the structure. The fire did not originate on the exterior of the house. This is consistent with NFPA 921 6.4.2.

Figure 34: A side and D side of home.

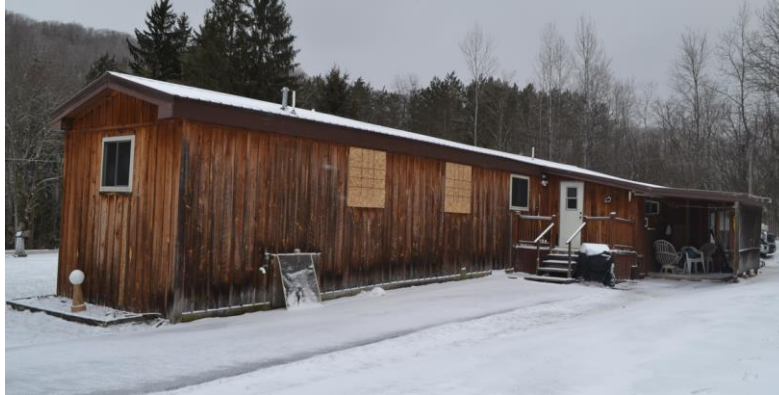
Figure 35: C Side and D side of home.

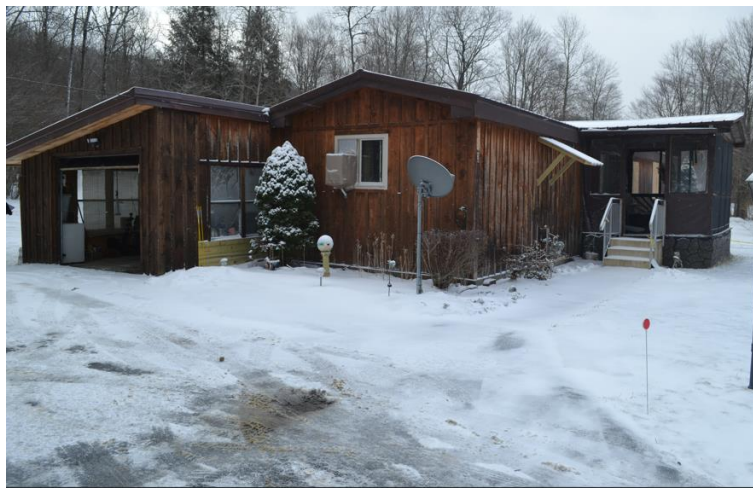
Figure 36: B side of home.

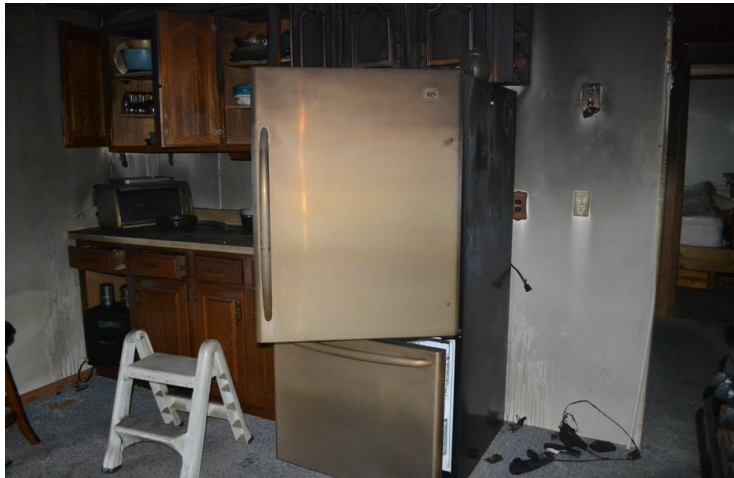
Kitchen: Varying degrees of soot deposition (consistent with NFPA 921 6.1.2.2.2) was observed on the kitchen structural surfaces and contents. The greatest degree of soot accumulation was observed near the upper regions of the room. Surface charring (consistent with NFPA 921 6.2.2.1) was observed on wall mounted cabinets and the upper regions of a sliding glass door frame and pass-through opening. The damage observed in the living room was greater (in intensity and in surface area) than the damage in the kitchen, therefore FRT concludes that hot gases and smoke moved to the kitchen from the living room via the pass-through opening and the walkthrough opening.

Figure 38: Fridge side of kitchen.

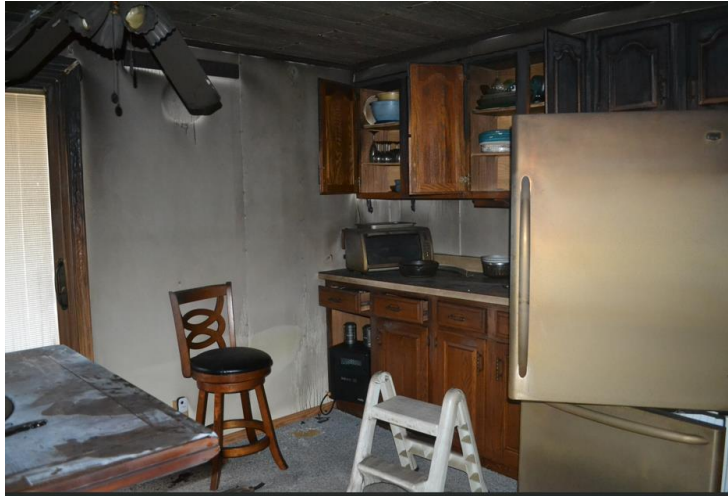
Figure 39: Kitchen photo, continued.

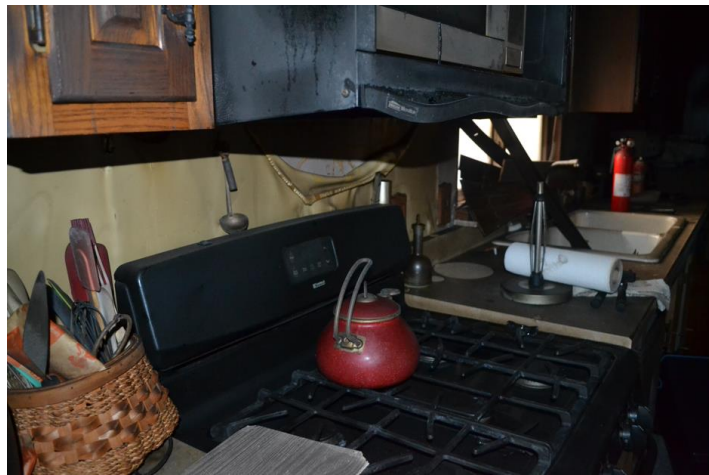
Figure 40: Stove and sink of kitchen.

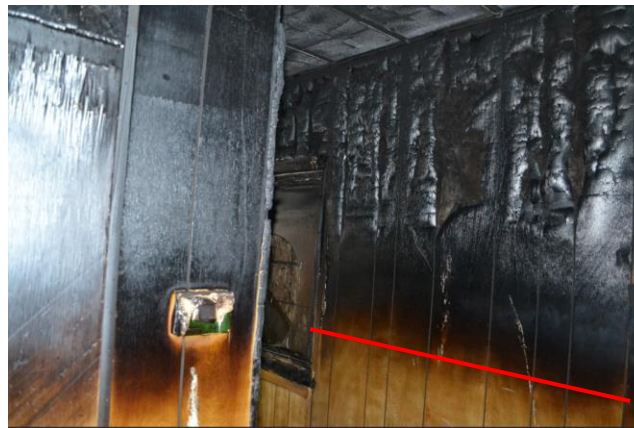
Figure 42: Hallway of the structure, showing a line of demarcation.

Hallway: The hallway floor was carpeted, the walls covered with Luan wood paneling, and the ceiling was composed of ceiling tiles. A line of demarcation was observed on the hallway walls which showed fire movement from the office with lateral movement in the hallway to the living room. The greatest degree of charring and mass loss on the hallway walls was closest to the ceiling. This is consistent with the presence of a hot gas layer, per NFPA 921 6.4.3.

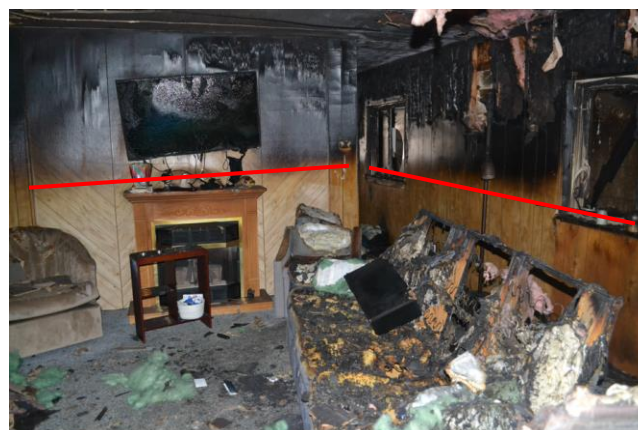
Living room: The living room was located in the middle of the structure, between the kitchen and the hallway. The living room was carpeted, the walls covered with decorative Luan wood panels, and the ceiling constructed with ceiling tiles. A line of demarcation was observed on the walls approximately 4 feet above the floor level. The line of demarcation indicated fire intensity and movement from the hallway to the living room. Surface charring was observed on the upper regions of the wood paneling. The greatest degree of charring and mass loss was observed on paneling where the hallway and living room were adjoined. Contents in the living room sustained varying degrees of fire, thermal, and soot damage. A sofa was located near the hallway, and it sustained the greatest degree of mass loss, charring, and discoloration when compared to other furniture in the room. Fire effects observed on the furniture and other contents in the living room were consistent with

Figure 43: Living room, facing Hallway.

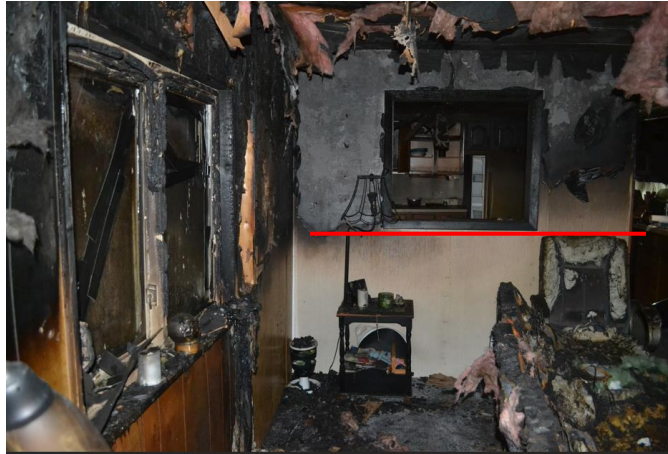
Figure 44: Living Room, facing Kitchen.

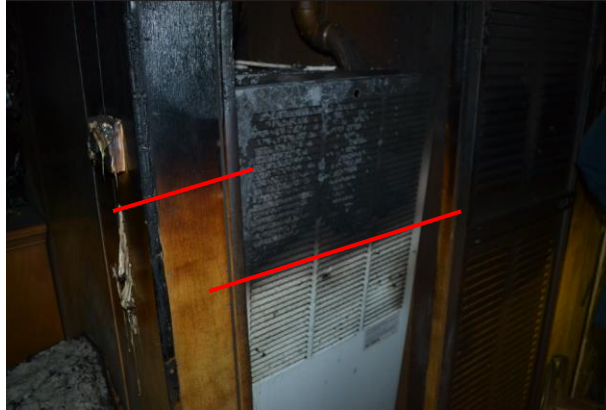
Figure 45: Furnace in hallway.

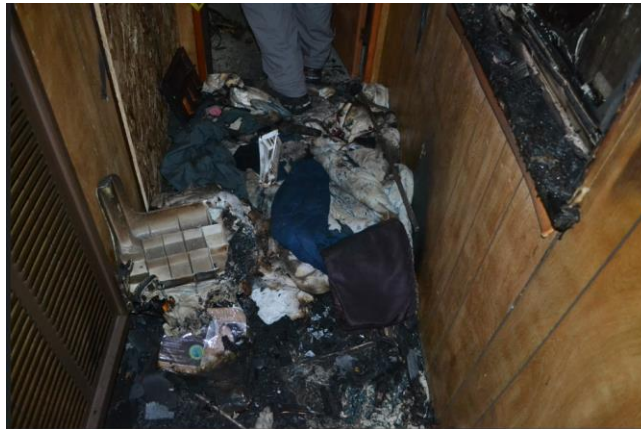
Figure 46: Hallway floor.

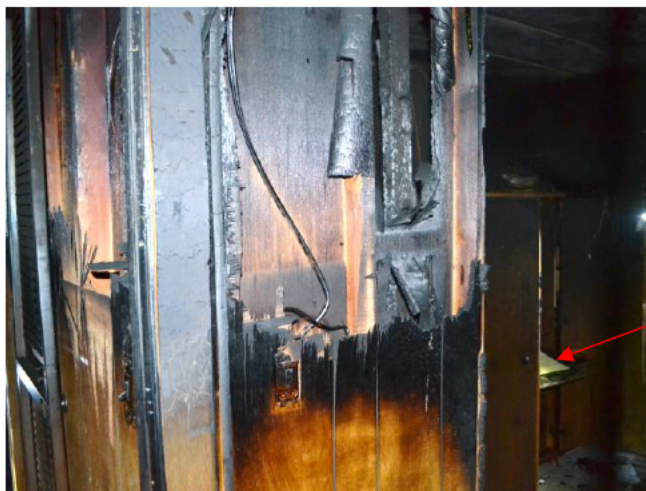
Figure 47: Fire damage outside office into hallway (red arrow indicates HP laptop).

The fire patterns (formed by fire effects) that were observed on the office door are consistent with the door being in an open position at the time of the fire. This then allowed the fire to progress from the office, and to spread vertically and horizontally along the path of least resistance, down the hallway via the open door.

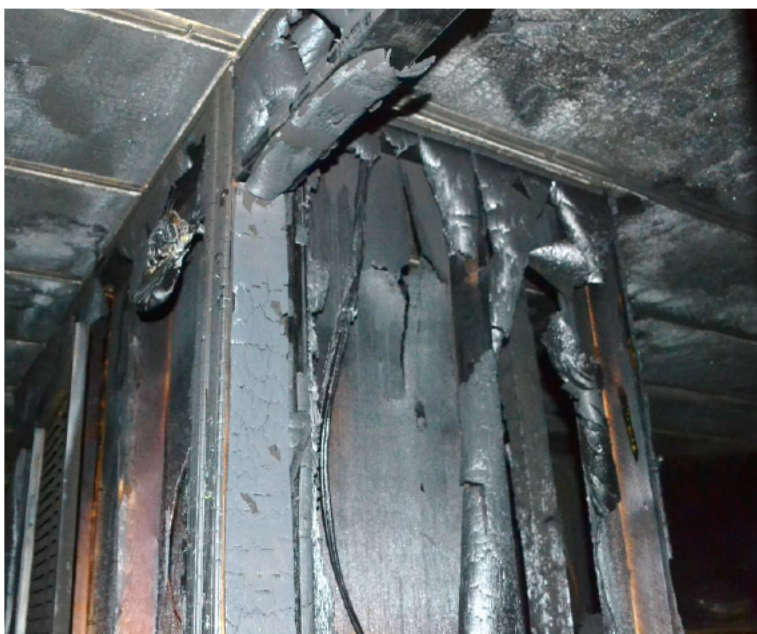
Figure 48: Ceiling area just outside opening to office in hallway.

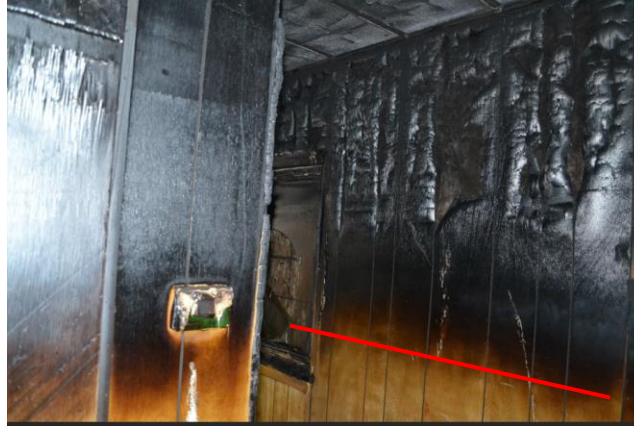
Figure 49: Hallway, viewed from the Living Room.

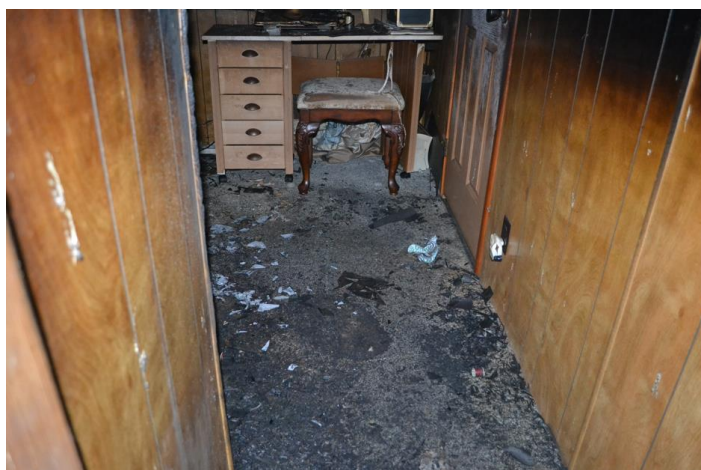
Figure 51: Floor, entry to office.

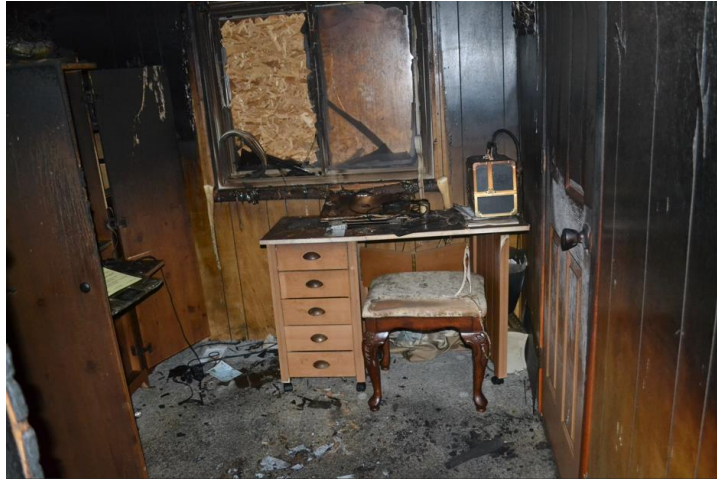
Office: Consistent with the kitchen and living room décor, the office floor was carpeted, the walls covered with Luan wood panel and finished with tile ceiling. The office contained a desk with cushioned stool, an armoire and a bookshelf. There was a closet in the office. A line of demarcation was observed on the walls approximately 4 feet above floor level. The line of demarcation delineated a higher degree of fire damage on the upper regions of the walls when compared to the lower regions. The damage observed on the walls was consistent with a hot gas layer (per NFPA 921 6.4.3). The desk and cushioned stool sustained the greatest degree of thermal damage, on the top surfaces of each, from radiant heat exposure. The armoire contained an HP Pavilion laptop, monitor, and assorted lightweight combustibles (including paper). Melted plastic was observed on the laptop screen, resulting from downward dripping consistent with the computer being in an open position at the time of the fire. Pronounced damage by thermal and fire attack was observed on the computer around the battery compartment. The damage observed on the laptop was isolated, and inconsistent with (of greater intensity than) damage to other contents in the room.

Figure 52: Office, sewing table straight ahead, armoire to left in photo.

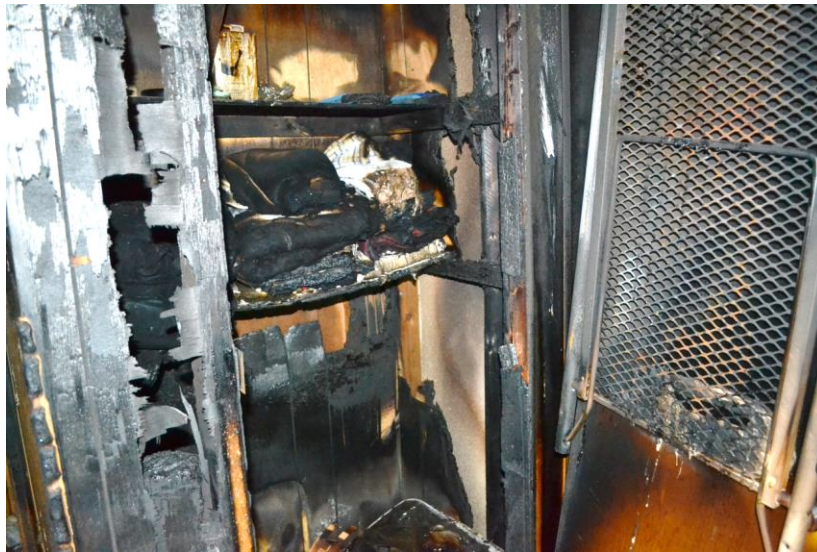
A closet was located to the left of the bookshelf. Fire patterns (formed by fire effects) that were observed on the closet door are consistent with the door being in an open position at the time of the fire. A metal frame portable ironing board was hung on the inside of the closet door. The ironing board frame sustained the greatest degree of oxidation on the side facing the closet and its upper region. Patterns observed on the ironing board are consistent with fire movement from the closet to the office. Most of the Luan wood panel walls in the closet were consumed, and shelves had collapsed. Burned contents were

Figure 53: Closet within the office.

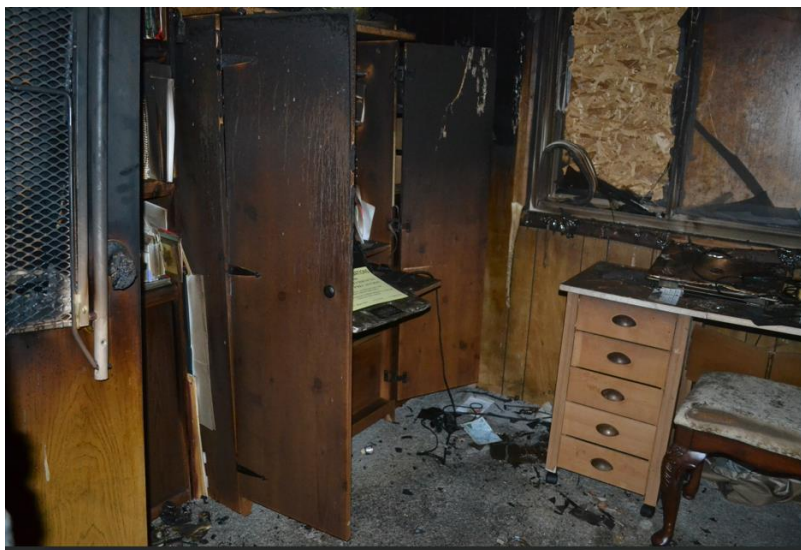
Figure 54: Area of origin.

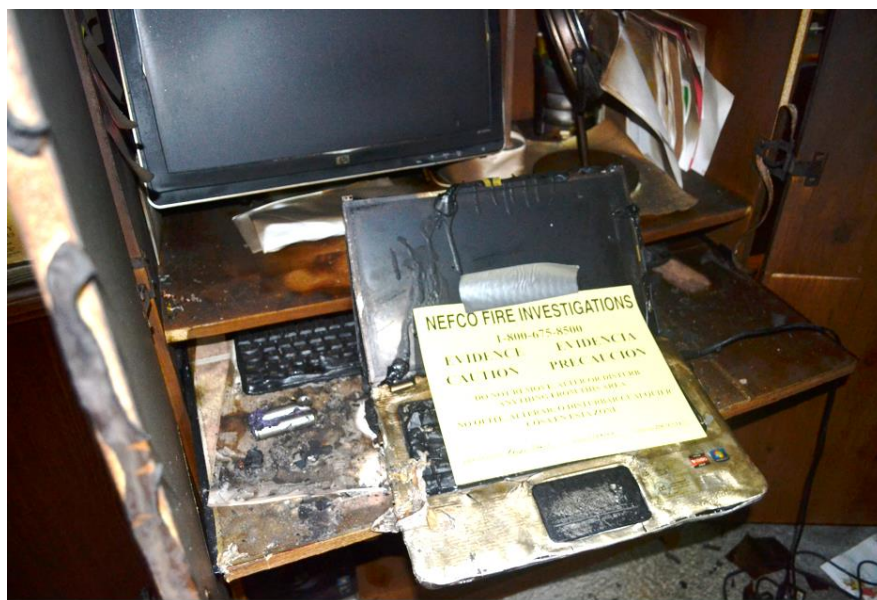
Figure 55: Close-up of the area of origin.

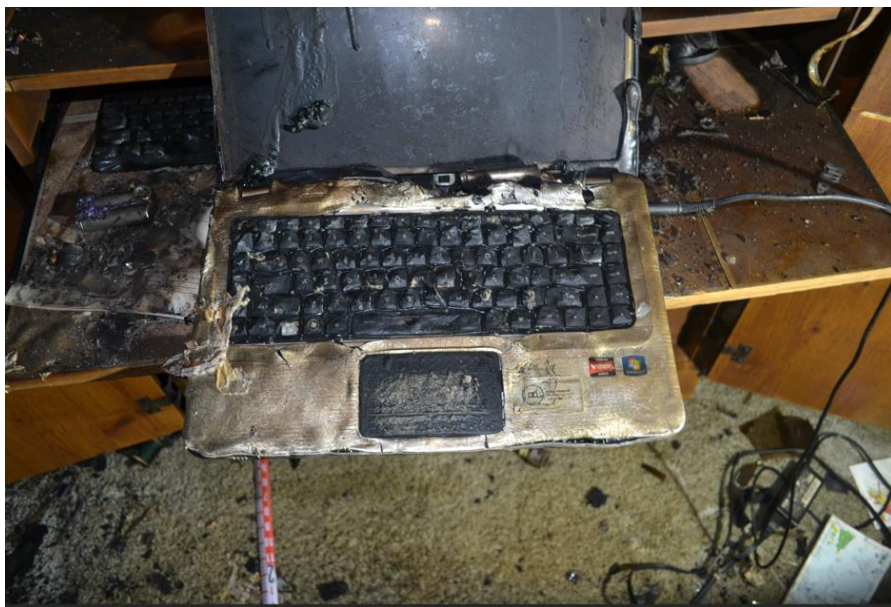
Upon looking more closely at a HP laptop computer located on a pull-out shelf of a computer cabinet (Pic 59-62) the FI team saw unusual looking damage to the area between the keyboard and the screen (Pic 60). We picked up the HP laptop and observed additional damage to the paper (Pic 61) under the battery cover area. We also observed damage to the battery cover and the battery located in the laptop. (Pic 62, 69). This area of the battery cover showed an inconsistency with damage from a fire spread. It should have been a protected area. We confirmed that this HP Laptop was plugged in (Pic 66, 67). We also confirmed that breaker # 4 (Pic 50, 51) had been tripped. It had a sub label as LR.

Figure 56: Keyboard area of HP Pavilion Laptop.

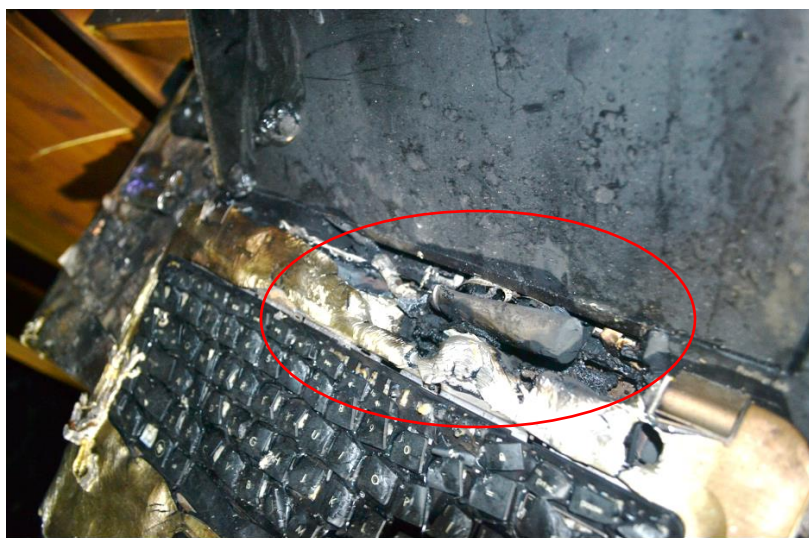
The power cord for the laptop sustained only minimal thermal damage to the exterior coating of the cord. The outlet that the laptop cord was plugged into was undamaged. Battery remains were found directly adjacent to the laptop, on the floor and in the desk area of the armoire. There were also battery remains found in a can near the armoire. In following the scientific method set forth by NFPA 921 3.3.171 (see Figure 2, herein), Mr. Litzinger documented and evaluated the electrical system of the structure. Per his observations and documentation, he observed both circuit breaker #4 and the main breaker of the home in the OFF position. In contrast, Mr. Litzinger confirmed that circuit breaker #3 was the circuit providing power to the outlet into which the laptop was reported to be plugged, located on the C wall of the room of origin.

Figure 57: The red highlight encircles the battery remains reported as the HP Pavilion laptop.

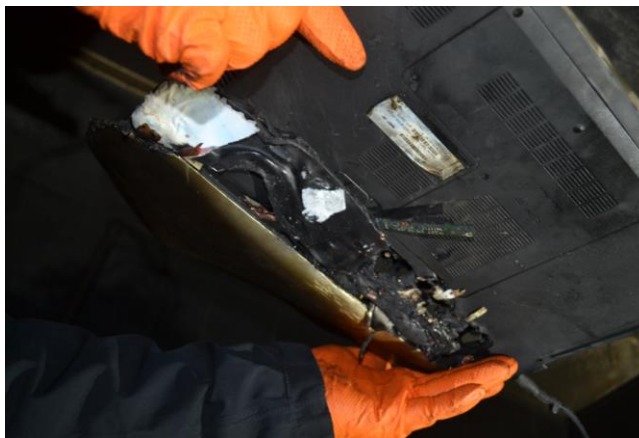
Figure 58: Under-side of HP Pavilion Laptop.

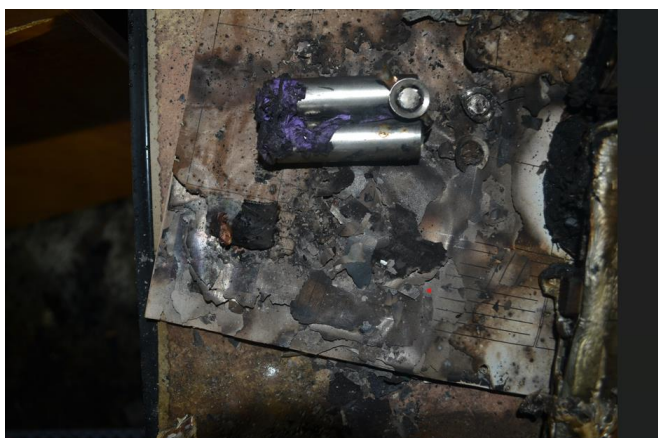
Figure 59: HP Pavilion Laptop battery remains documented within the room of origin.

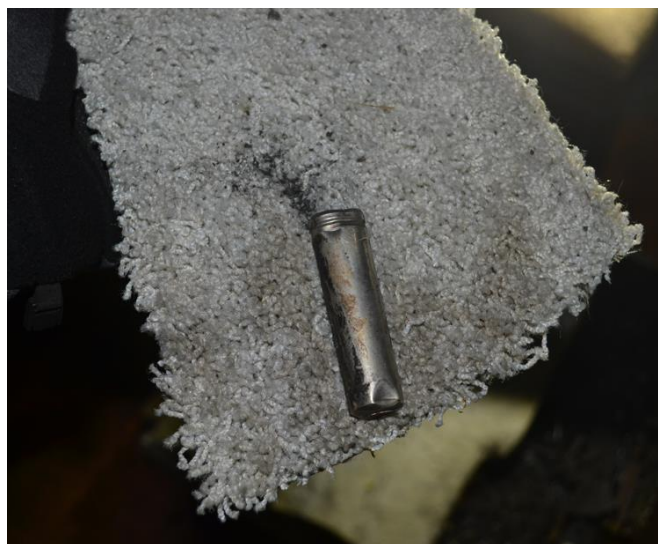
Figure 60: Additional battery remains from HP Pavilion Laptop documented within the room of origin.

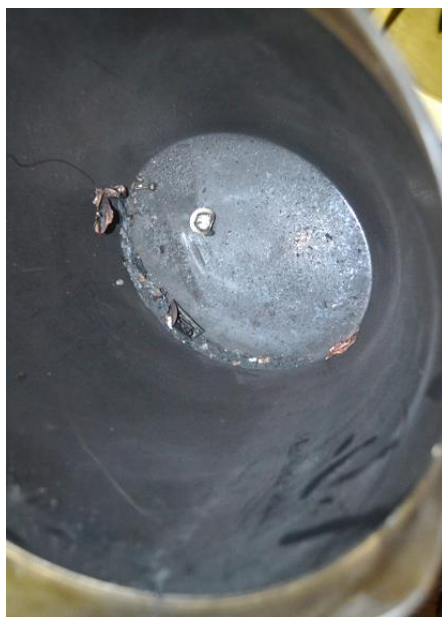
Figure 61: Battery foil and battery vent cap remains, documented within the room of origin.

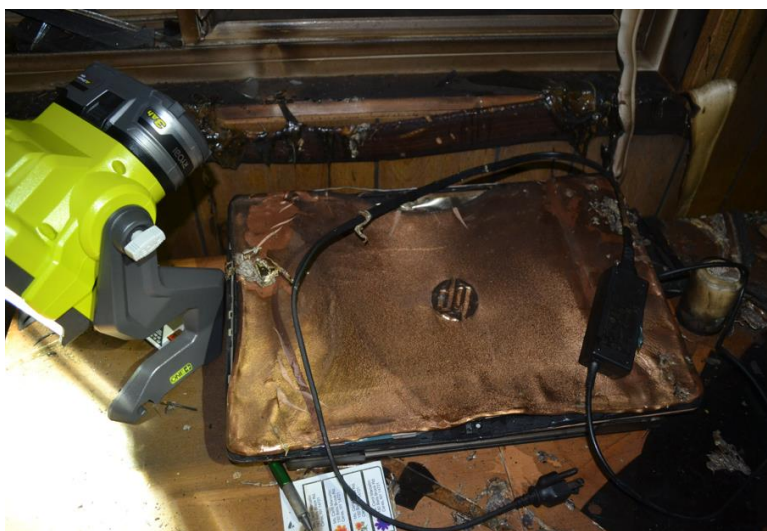
Figure 62: Remains reported as the HP Pavilion Laptop, including power cord (still intact).

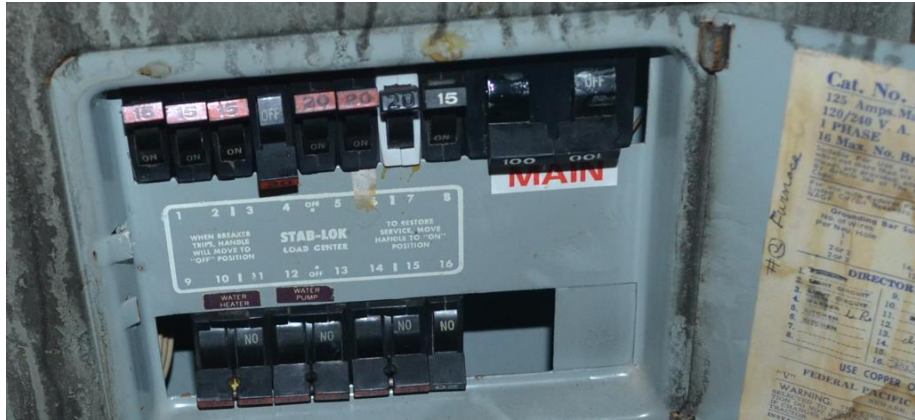
Figure 63: Breaker number 4, documented in the off position (Labeled 'L.R.', to the right).

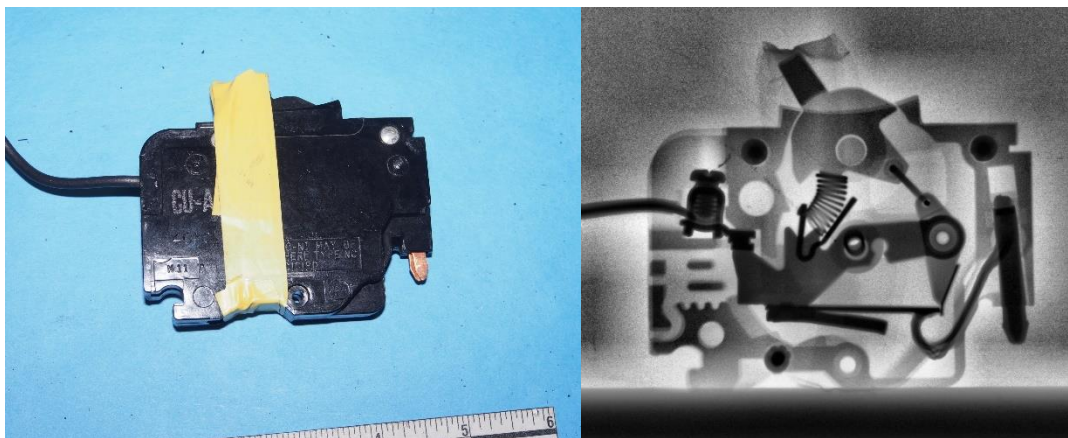
Figure 64: Evidence Item #9, Circuit Breaker #3. Examined (x-ray and visual) and forensically eliminated, per A. Litzinger.
